Navajo Abandoned Uranium Mine

Site Screen Report

**Mine Name: Claim 35
Mine ID: 80**

August 2011

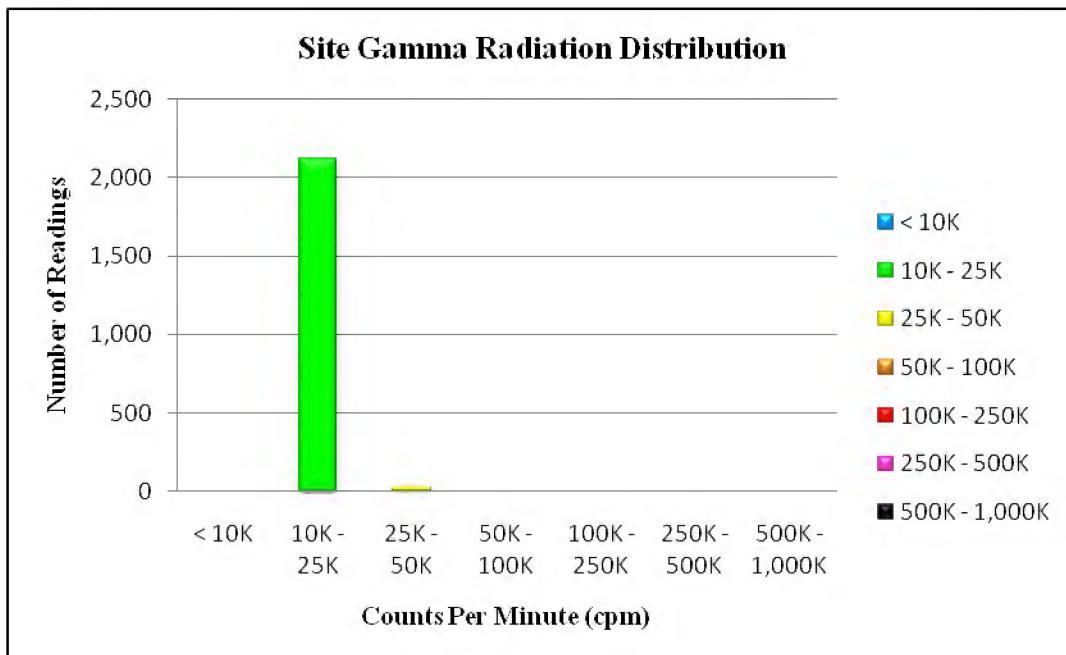
Highest gamma radiation measurement: 33,356 counts per minute (cpm)

Background Average: 13,489 cpm **Two Times Background:** 26,978 cpm

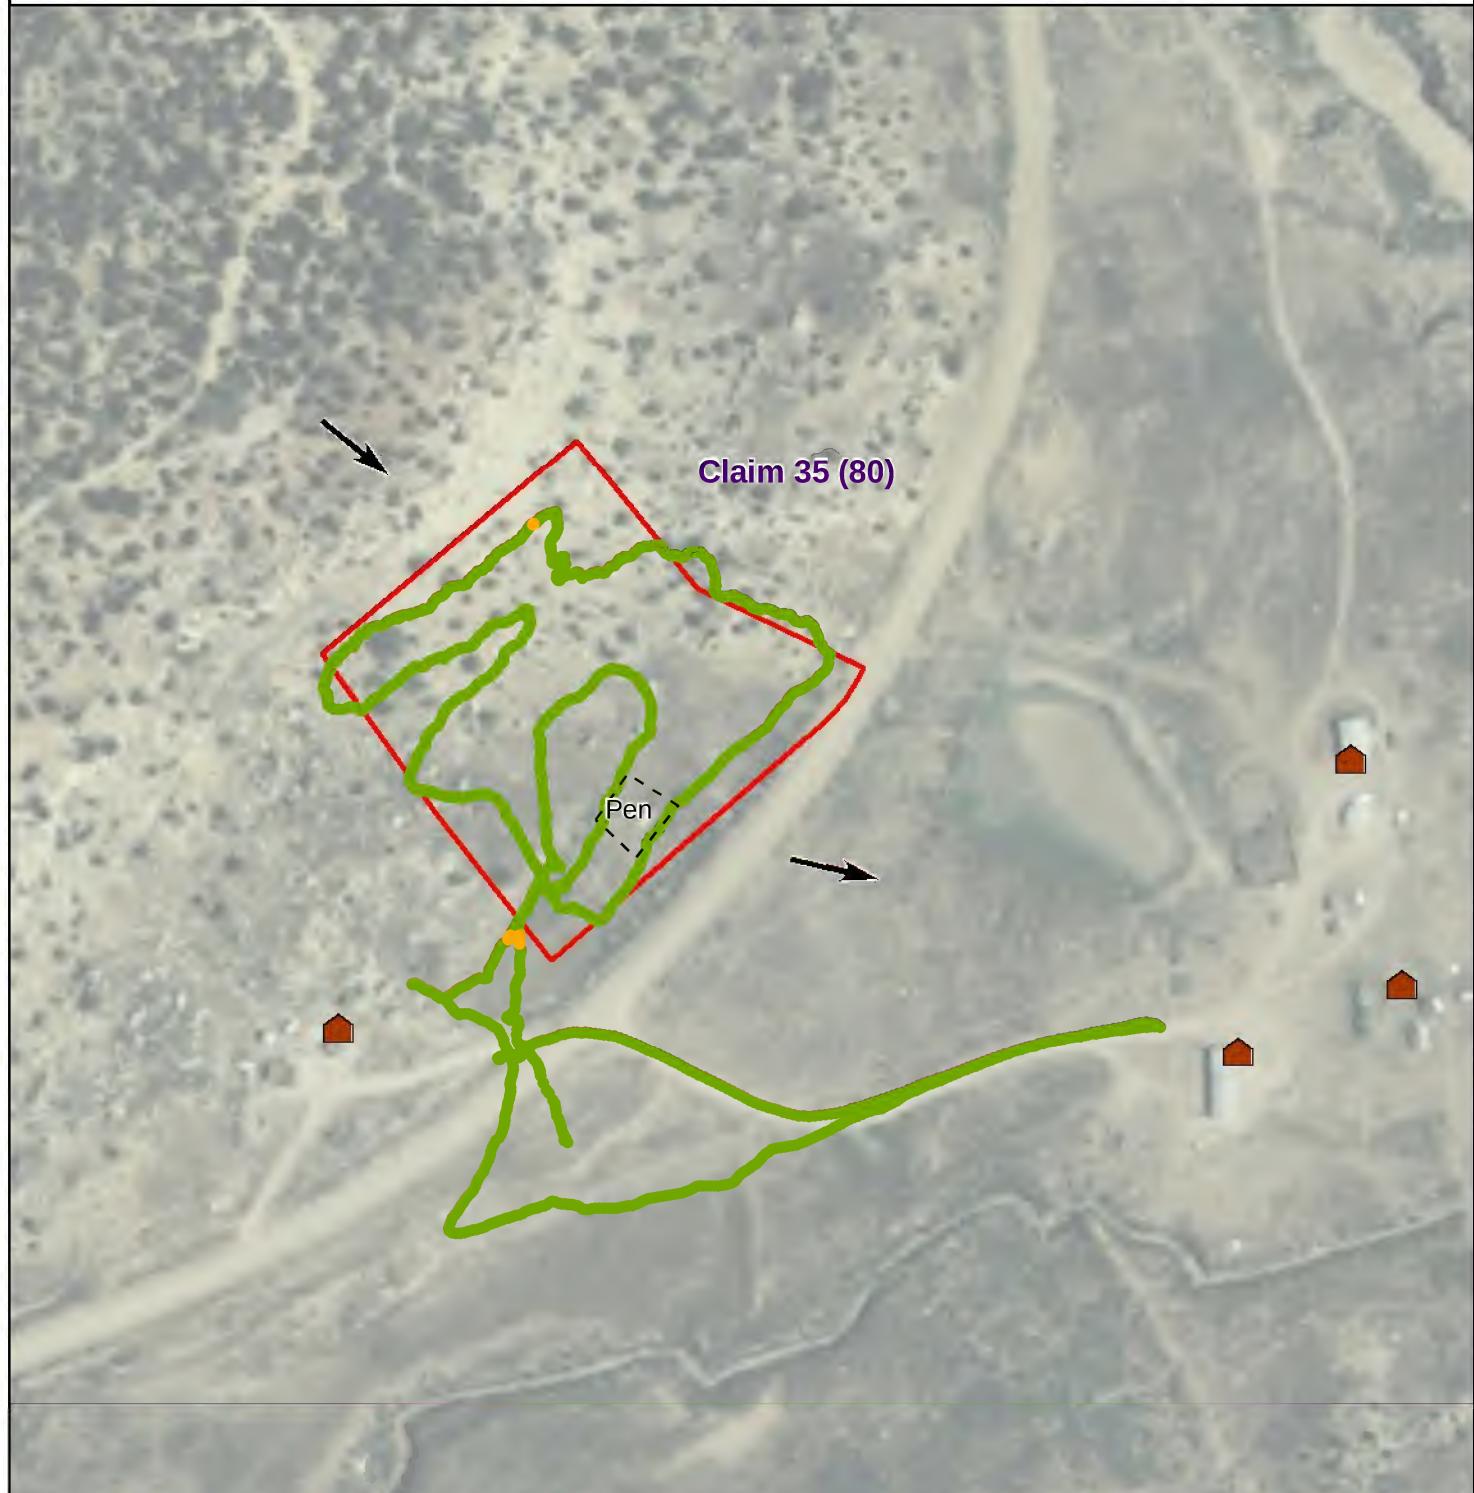
A total of 2,136 gamma radiation measurements were collected from the mine site, ranging from 12,372 cpm to 33,356 cpm. The measurements are represented in Figures 1 and 2.

Figure 1 - Gamma Radiation Measurements, Above Two Times Background
Claim 35 (80)
Tachee Chapter, Navajo Nation

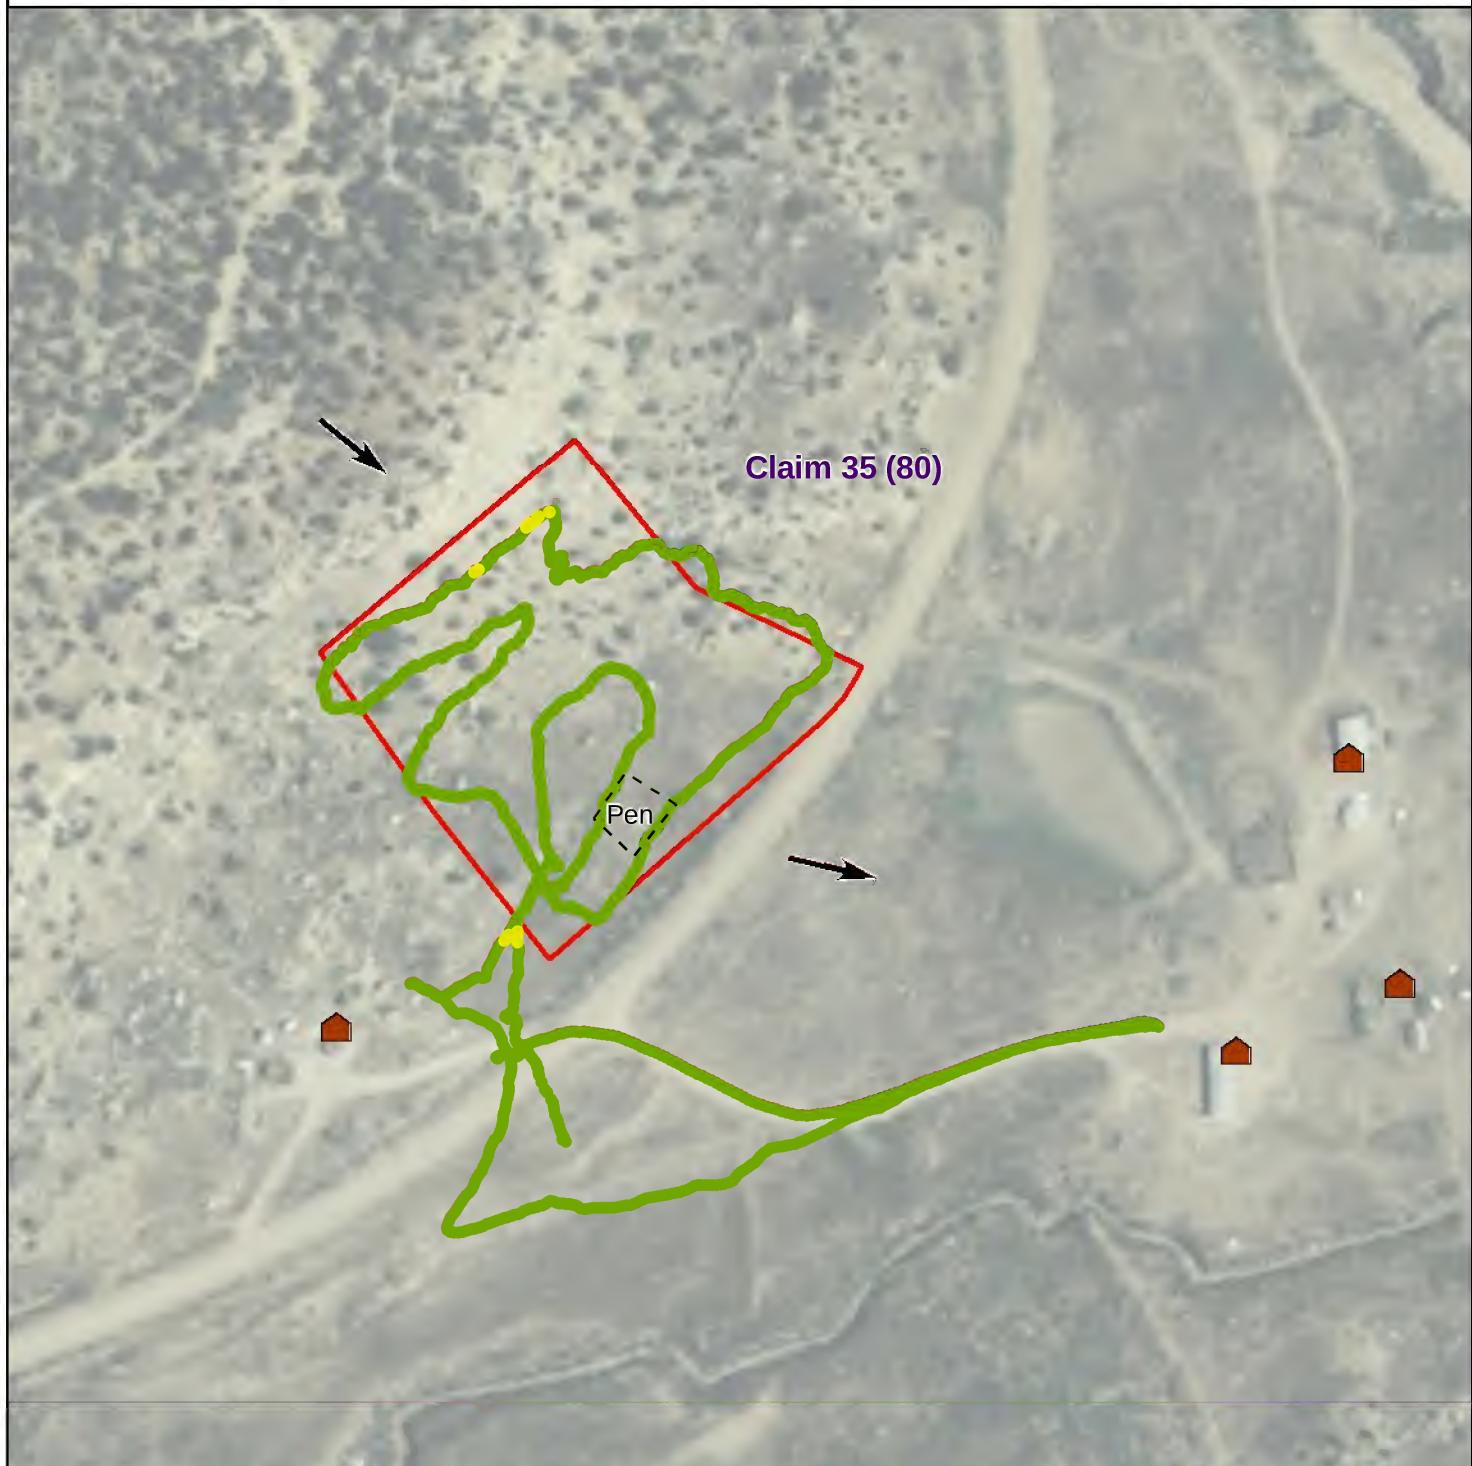
Figure 2 - Gamma Radiation Measurements
Claim 35 (80)
Tachee Chapter, Navajo Nation
